Stress-strain analysis of works remediation implemented to stabilize the mining subsidence under La Inmaculada School, Zaruma-Ecuador

Burbano Danny | Universidad Central del Ecuador, Quito, Ecuador

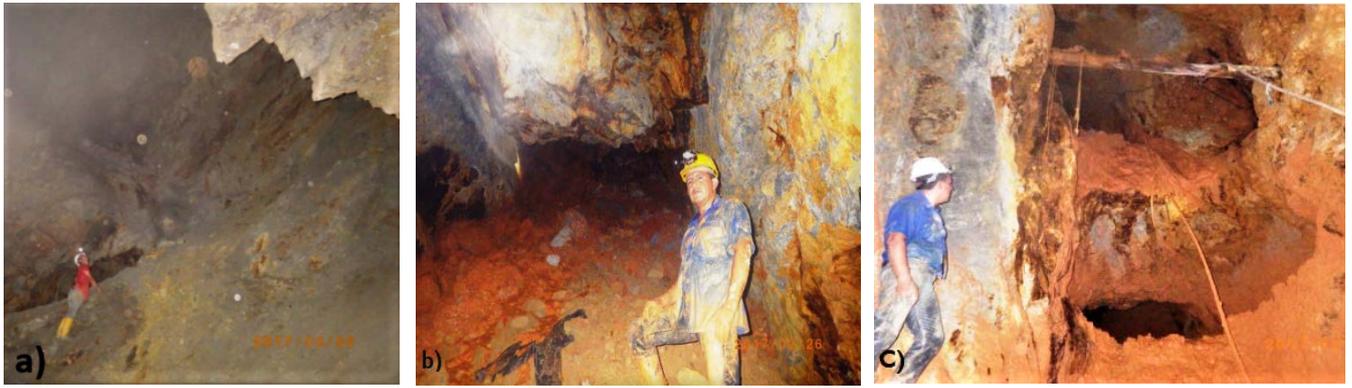
Figure 1. a) mining work (18 high x 20 length x 10 width), b) gallery that causing the land subsidence on the surface, c) anti-technical and unsafe exploitation

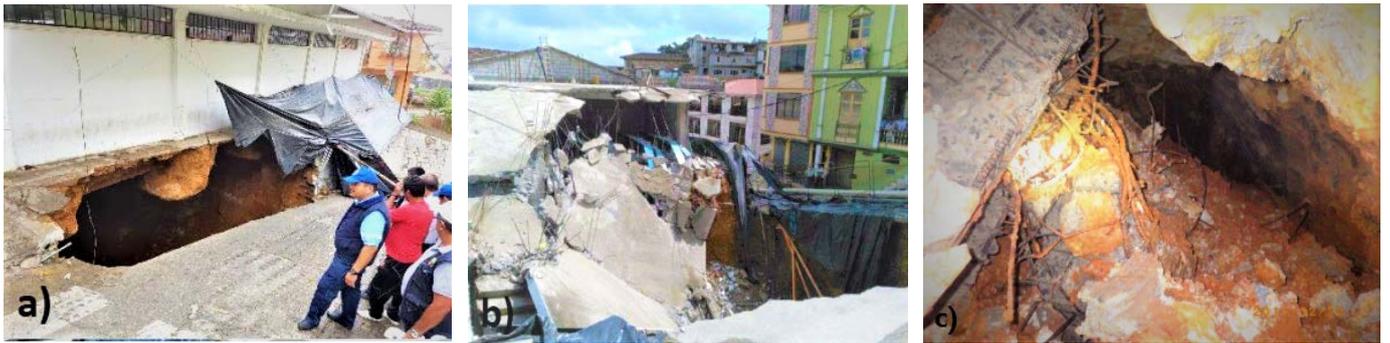
Figure 2. a) collapse start with 10 m cone, b) unstable structures, c) rubble (columns, hoses, cables, blocks) inside the gallery that caused the ground subsidence on the surface

The ground subsidence, that occurred on October 25th, 2016, at «La Inmaculada» school in the «Zaruma» city, was related to rock mass settlement and initial cone formation of 10 m in diameter until increase to 23 m, involve the inhabitant's safety and the architectural stability of surrounding houses (see Figure 2).

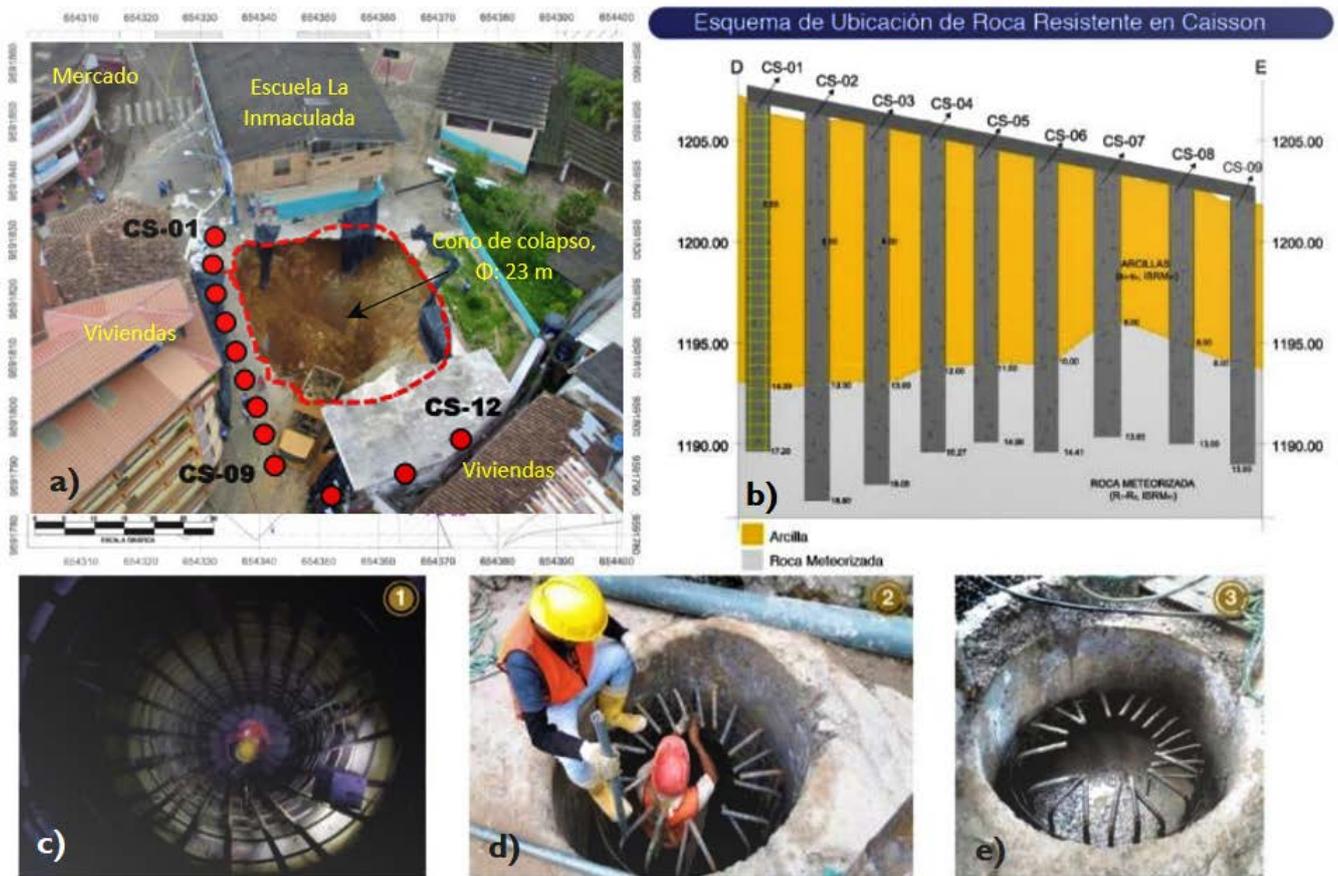
Figure 3. Location (plant and profile) and caisson-type stilt construction process (CS-#)

Phase two (remediation), is based on the twelve caisson type piles construction in situ (280 kg/cm² structural concrete with reinforcing steel $f'y$: 4200 kg/cm²) with internal diameter de 1,2 m arranged every 3 m embedded in rock to 19 m average depth, they are raised by a mooring beam and screen of armed structure, which together forms a perimeter structure, whose objective was to stabilize the houses near the subsidence zone (see Figure 3).

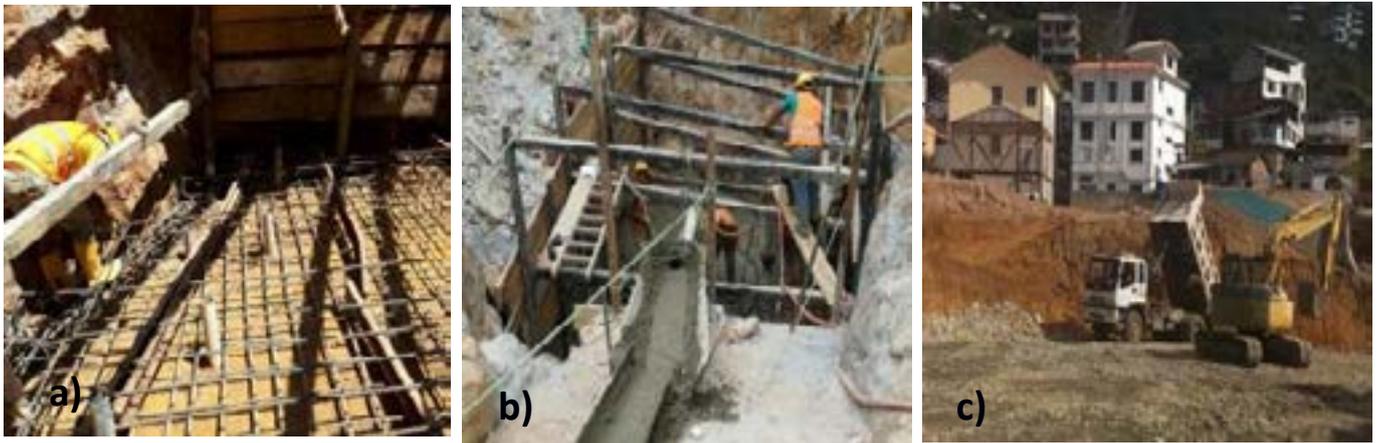
Figure 4. a) mortal level + drains + viga perimetral + armed with iron, b) slab cast, c) fill with class three sub-base compacted material

Subsequently, the interior of the cone is cleaned until reaching the competent rock, where a $\pm 4m \times \pm 5m$ plug slab was built with a reinforced structure (0,40 m replanning + electro welded mesh + perimeter beam + 16 anchored micro-piles + double iron grating with diameter: 18 mm @ 0,14 m + HB profiles + 0,40 cm of 350 kg/cm² concrete) and drainage.

Finally, the backfilling of the cavity is with 6000 m³ of compacted till material (sub-base class 3) up to the natural ground profile (see Figure 4) (INIGEMM, 2017).

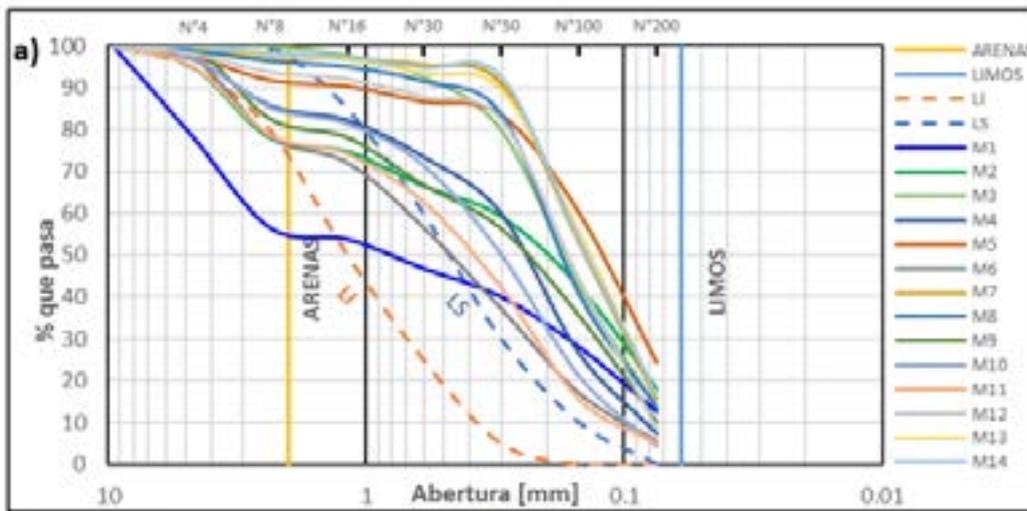
Figure 5 a) Granulometric curves of the relay compared to fourteen samples obtained from tailing "El Tablon" b) Surface saturation of the tailing for the material thinner than 75 um calculation c) Organic impurities in the mining tailing, according with the normalized data, it is one, suitable for use in concretes or mortars. d) Granulometry test e) Density relative calculation; wet, dry and tailing percentage absorption f) 1 Kg of the three process mixed tailings (cyanuration, flotation and gravimetry) g) Weight volumetric calculation of tailing average with 1596.12 kg/m³ h) Hydrogen potential measurement (pH) in tailing sample.

The criteria considered in the mortar cylinders elaboration (cement and tailings) was based a mortar design that the resistance conditions and fluidity with cement and tailings ratio 1:2. For their preparation, analyzes were carried out with ASTM standards for arid in concrete and mortar (see Table 1, Figure 5), in order to could be used tailings sands or not.

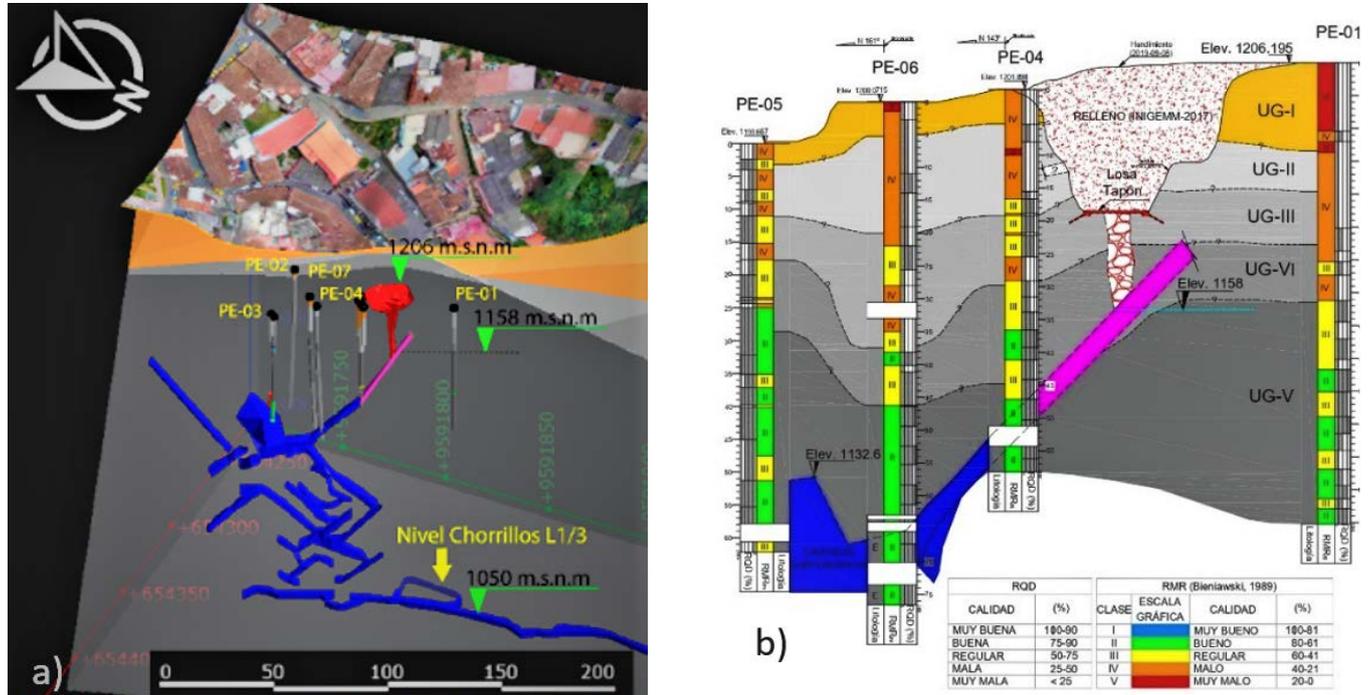
Figure 6: a) 3D Geological-geotechnic model b) Areas between exploration probes PE-01, PE-04, PE-06, PE-05, where it is showed; five levels of weathering, RQD and mass rock quality according to Bieniaswki, 1985. Source: Modify INIGEMM, 2017 y Rivadeneira, A.,2021.

Figure 6 represents the geological model with the galleries spatial distribution that took advantage of the «Tres Reyes» vein (blue solid), from the level «Chorillos» L1/3 level (dimension: +- 1050 m. s. n.), up by multiple mining excavations (trunk-irregular sections between +- 5 and +- 45 m²) inclined to 45° (recess) (see Figure 6). The gallery located in the dimension +- 1158 m. s. n. (magenta solid) was the cause of instability of the rock mass under the «La Inmaculada» school, where the conditioning factors (low lithostatic load, intense weathering, unfavorable geological structures, minimal geomechanically properties) and triggers (high precipitation, classrooms static load, dynamic blasting load, tension state by mining excavations) affected the resistance rock mass loss, producing an subsidence accelerated phenomenon of soil to consecutively occur the sinking with cone conformation up to 23 m in diameter (dimension +- 1206 m. s. n.) and collapse chimney +- 40 length (red solid) (INIGEMM, 2017).

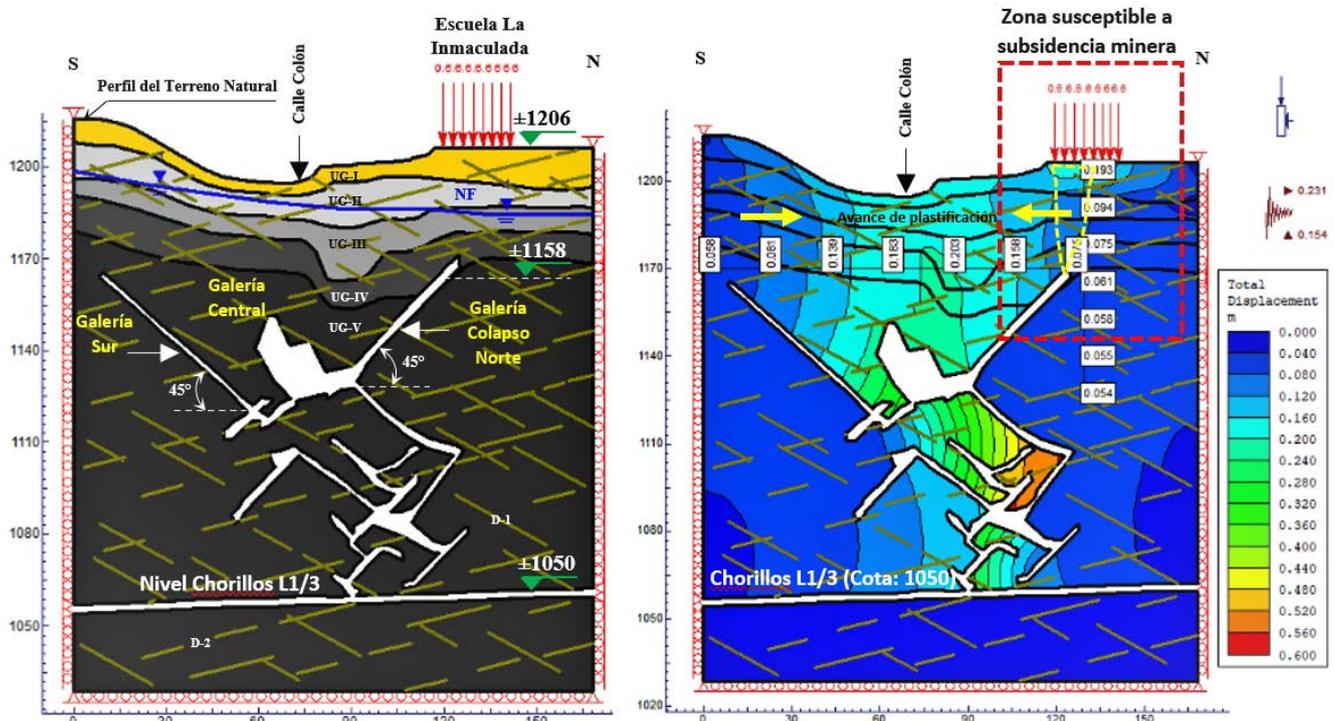
Figure 8. a) pre-collapse geological model, b) stress-strain model with areas plasticized development. «La Inmaculada» school there is evidence of disturbed zone. The isolines show the cone configuration and tendency of the collapse chimney (yellow line).

Geological model: Figure 8a, showed the spatial distribution of weathering levels with the join systems (D1 and D2). With the color white represents the mining excavation's location that up from the «Chirillos» gallery L1/3. With red color represent the school «La Inmaculada» dead load and the water ground level position (FN) with blue line (see Figure 8a).

Stress-strain Model: Figure 8b, showed the total strain behavior, with values of 20 mm in the area where the school «La Inmaculada» was located (see Figure 8b). It showed from south gallery (level: 1166 m. s. n. m.) to the north gallery (level: 1163 m. s. n.) with maximum strains up to 30 mm above the central gallery (28 m x 18 m). In the central lower, it's possible it's to strain increase happened in the center, this is to the geometric configuration of galleries excavated in anti-technical way, and taking advantage of the pillars that provide safety.

- *Scenario 1, before collapse (October, 2016)*: the strain curve is maximum in the area between the central and north gallery; reaching displacements values between 10 mm and 20 mm, the development and advancement of these galleries disturbed the tensorial state, leading to the rock mass plasticizing between 0+50 and 0+132.

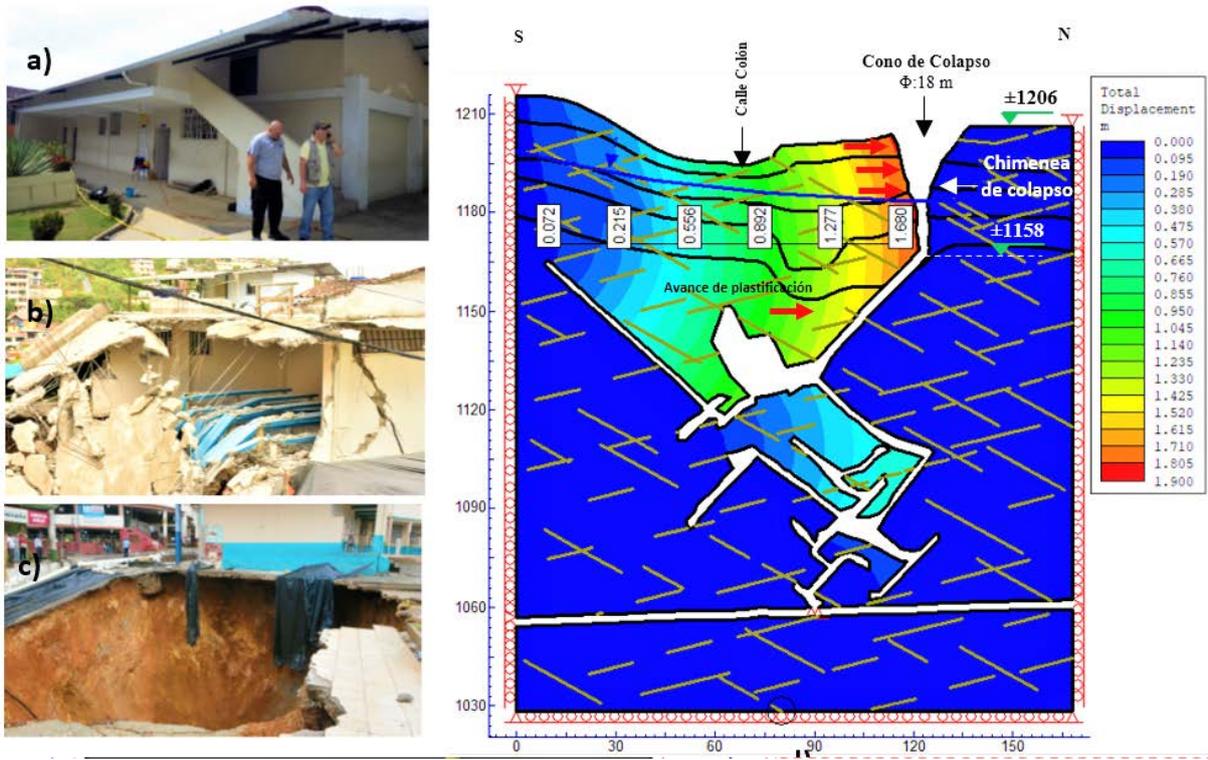
Figure 9. a) «La Inmaculada» school classroom (oct-2016), b) classroom collapse, c) cone (Φ:18 m) and chimney (L:34 m), d) stress-strain model where the strain develops parallel to walls of chimney reached displacements of up to 1,90 m

Stress-strain model: Figure 9d, the strain behavior showed in the collapse chimney sector, where occurred movement of 1.90 m. the strain isolines shows the rock mass relax inside of the cone (see Figure 9). This model represents the instability cone and chimney collapse behavior. That's occurred developed seven instability events; beginning on October 25th, 2016 with 10 m cone until on February 20, 2017 where the cone reached 31 m diameter. The stress modification generated an imbalance, at the moment ground sinking, causing the chimney walls collapse. (circular break).

- *Scenario 2, empty cone (February, 2017)*: when the first instability event, the cone and chimney collapse increased their diameter by the rock changes and efforts modification, conditional factors (lithology, favorable geological structures, weathering) and triggers (static and dynamic loads by blasting and earthquakes, stress disruption, runoff water infiltration), allowed a decrease in the rock mass resistance, causing surface subsidence to occur the sinking.

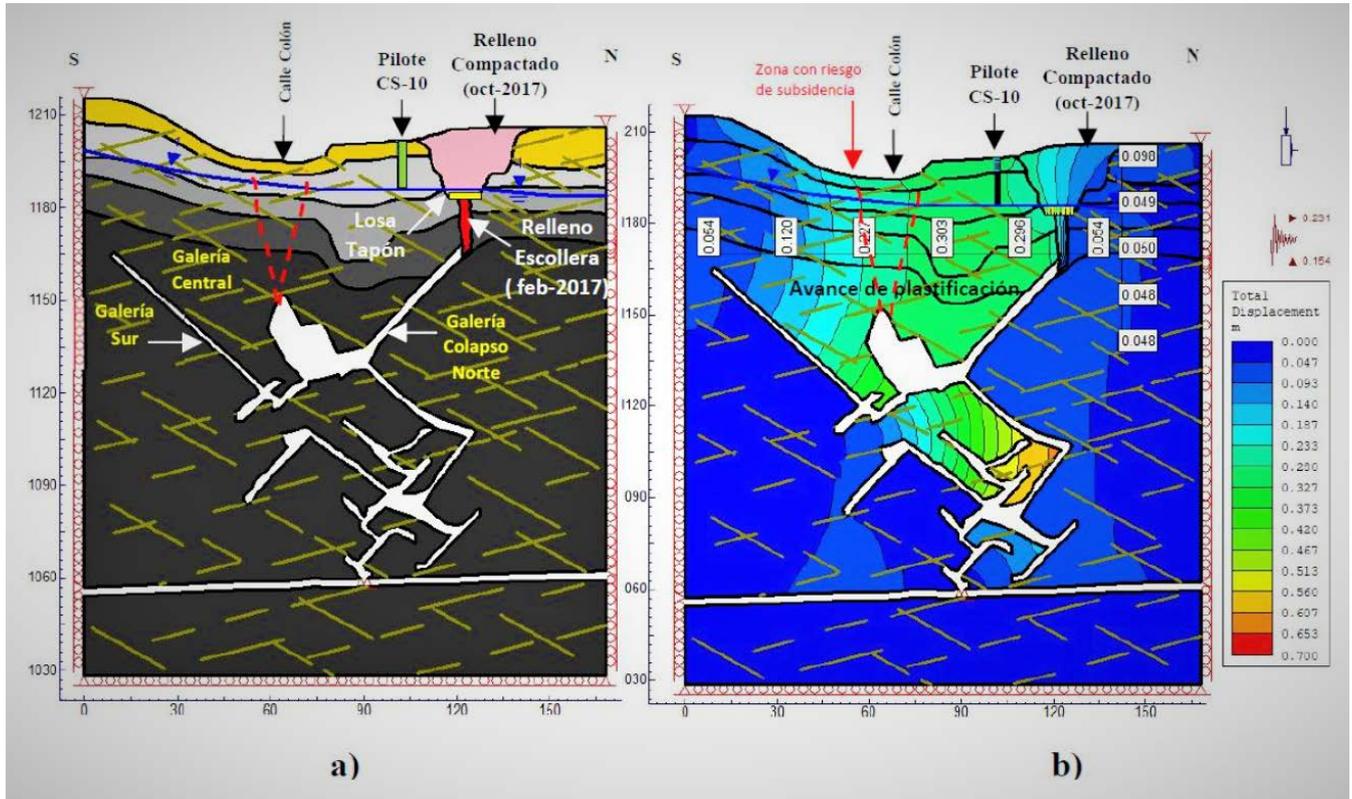
Figure 10. a) geological model with the mitigation works location; piles, sly plug and compacted filling, b) remediation works post-implementation strain behavior

Geological Model: Figure 10a, shows the geological part described before and remediation works that finished on October, 2017, where it is included; twelve caisson-type piles construction of 1.20 m diameter and average length of 19 m, 32 m perimeter screen of support in the reinforced concrete, slab stopperconstruction in beams moved and theses supported in sixteen micropiles (see Figure 10a).

Stress-strain model: Figure 10b, the total deformation behavior, after the remediation works, is showed reaching values of 5 mm in the area where the piles work was carried out (see Figure 10b). Evidence that the stabilization proposal implemented by INIGEMM (2017) was effective. It is important knew that the plasticizing from the south gallery to the north gallery strains of up to 30 mm above the central gallery, the area where the school is located

- *Scenario 3, Remediation (October, 2017)*: the mitigation works designed by INIGEMM, 2017 in the area under «La Inmaculada» school minimized the strain up to 5 mm, achieve the sector stability, in the other hand, the strain between the central gallery and the north gallery (0+50 and 0+132) showed values of up to 30

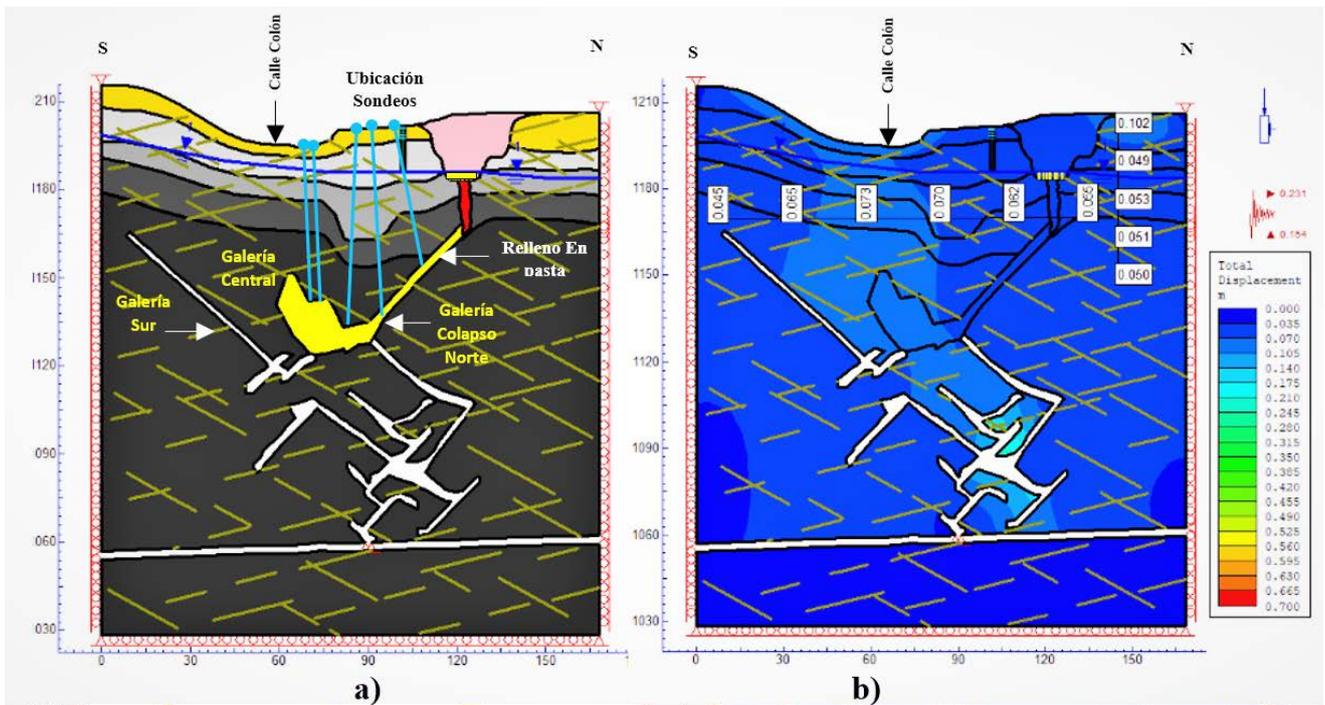
Figure 11. a) geological model, mitigation works and pulp filling, b) post-filling deformation behavior in pulp

Geological Model: Figure 11a, shows the geological part, mitigation works and the proposed pulp filling with a mortar design (cement and tailings ratio 1:2) (see Figure 11a). The mining excavations injection was proposed from the surface by five soundings (did in 2017: SE-3, SE-4, SE-5, SE-6, SE-7). Before filling, its built reinforced concrete topsons that block the mining galleries for the closing the injection system.

Stress-strain model: Figure 11b, it showed the filling effectivity using tailings sands how fine aggregate, the mortar designed after fourteen days had a simple strength compression of 10 MPa (see Figure 11b). The stress-strain model in the filling zone indicated lower values than 6 mm. the deformation behavior in relation to other galleries decrease, and plasticized areas low when the excavations were stabilized.

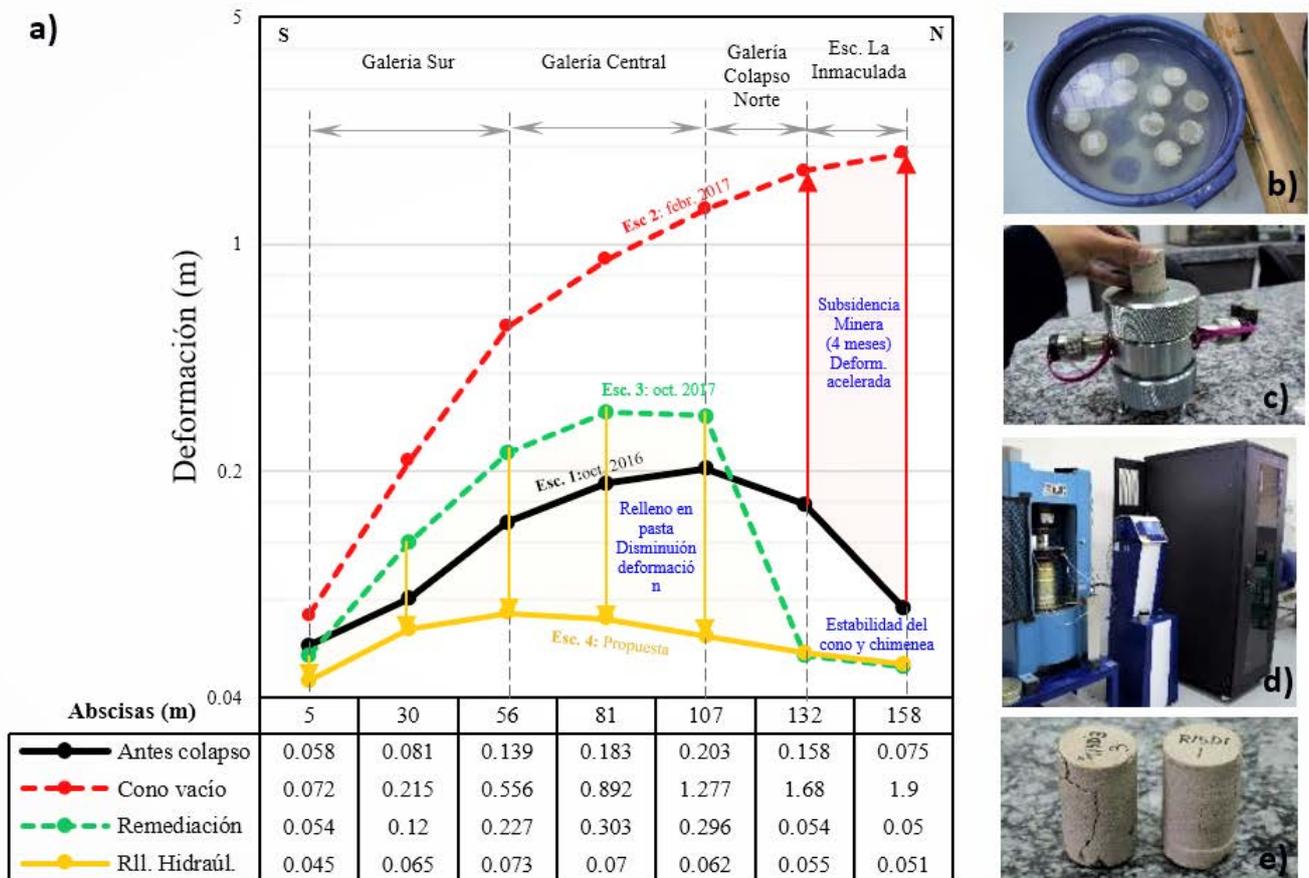
Figure 12. a) relation between on x-axis (scenarios 1-4) and maximum strain for events: before collapse (October, 2016), cone and collapse chimney gradual expansion (February, 2017), remediation works implementation, b) mortar cylinders (1C:2R), c) Hoek for triaxial test, d) simple compression test with modules, e) tailings and cement cylinders after breakage

The four stress-strains models show plasticizing rock mass state, by the mining galleries that were under school surrounding «La Inmaculada». Figure 12a shows the investigation results, in order to have a relation with strain and gallery's location in the longitudinal section with north-south direction:
